**DEBRIS CONTROL AT HYDRAULIC  
STRUCTURES IN SELECTED AREAS  
OF THE USA**

January 1996

Second Interim Report

US ARMY RESEARCH DEVELOPMENT &  
STANDARDIZATION GROUP-UK  
LONDON

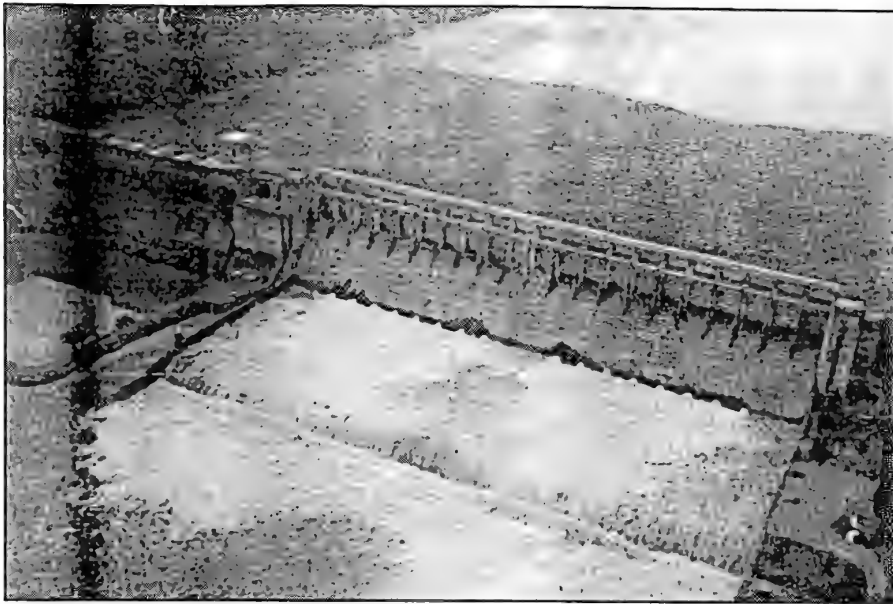
The larger debris accumulations span the width of the river valley and wedge against the dam face. A photograph of the March 1993 flood event is presented in Enclosure 3. Approximately 40 acres of drift and debris are observed prior to passage. In addition, a photograph illustrating the January 1995 event demonstrates how the debris compacts against the dam face. Approximately 35 acres of debris accumulated during the January flood.

Bluestone Dam, March 1993, Flood Event

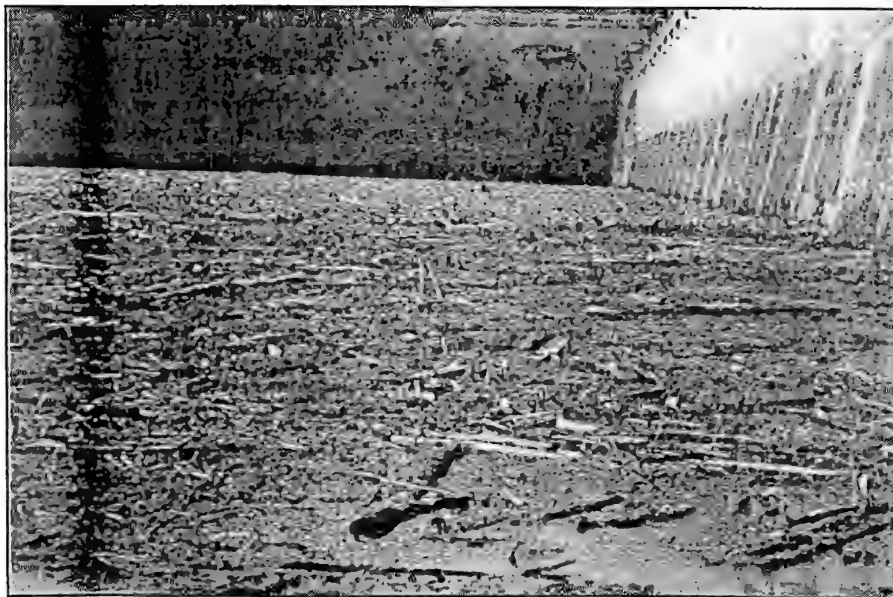
Bluestone Dam, January 1995, Flood Event

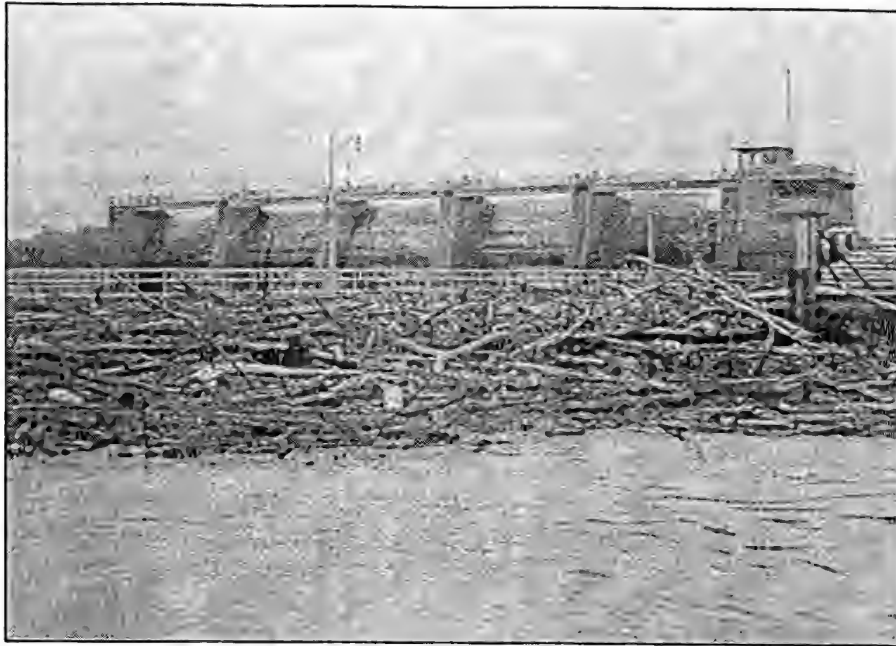
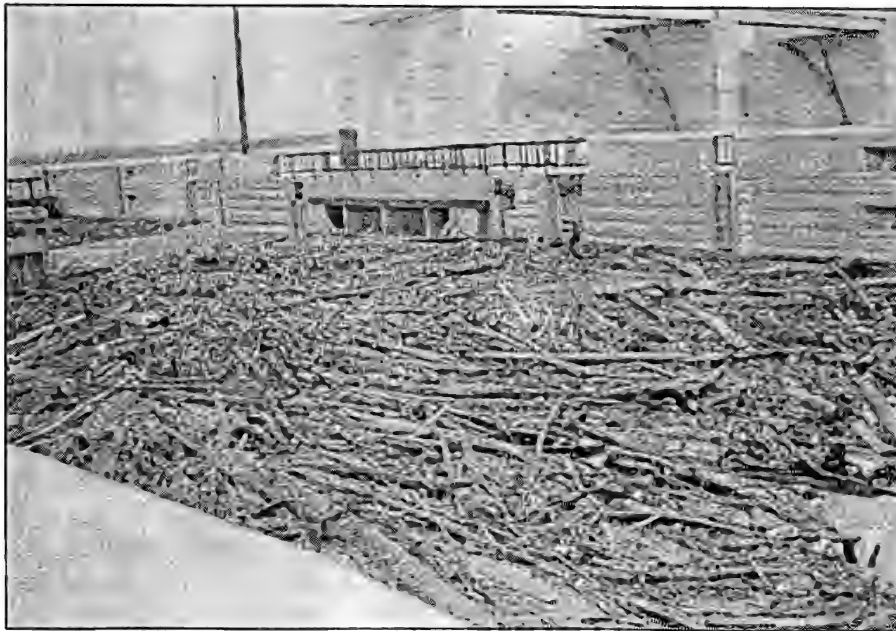
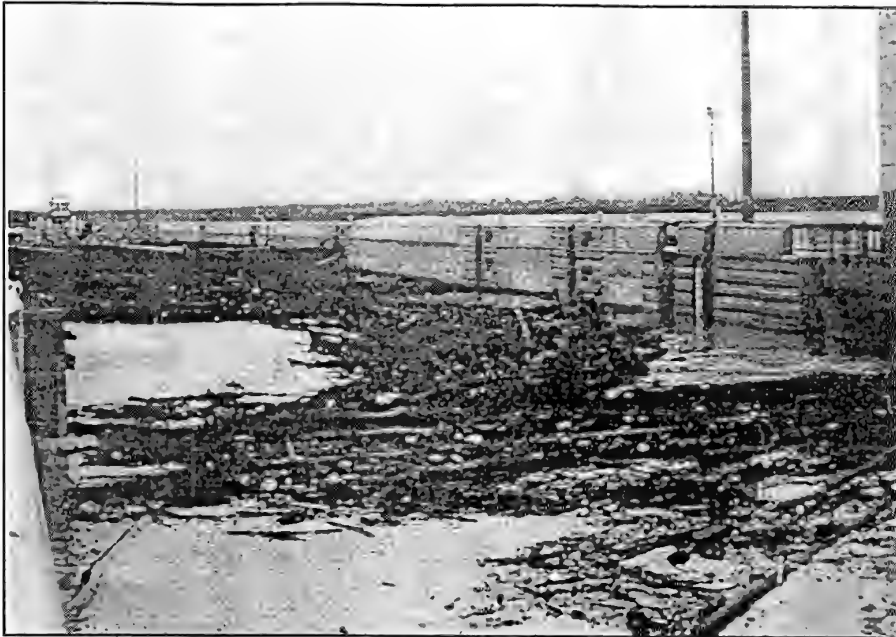
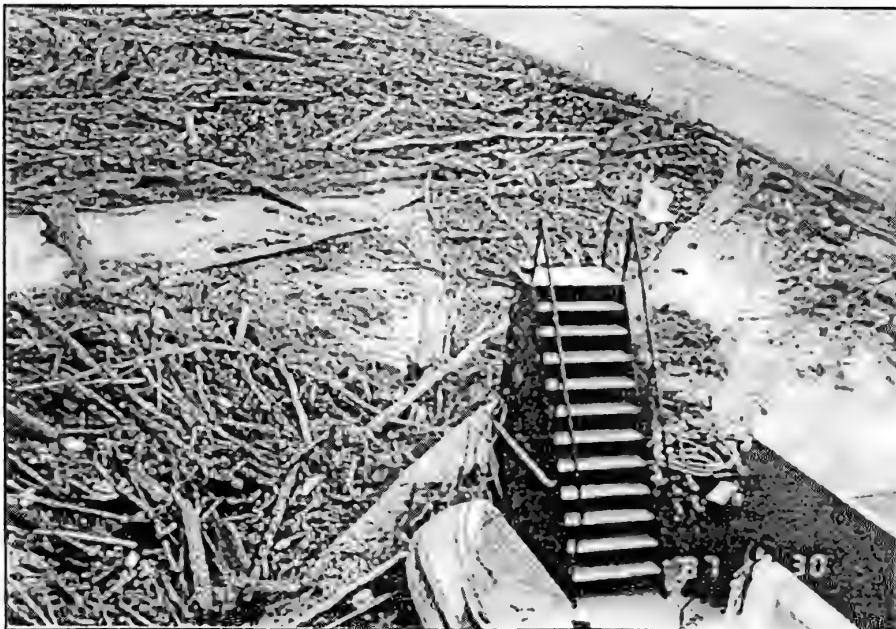
Typical log jam, Lock and Dam Operation

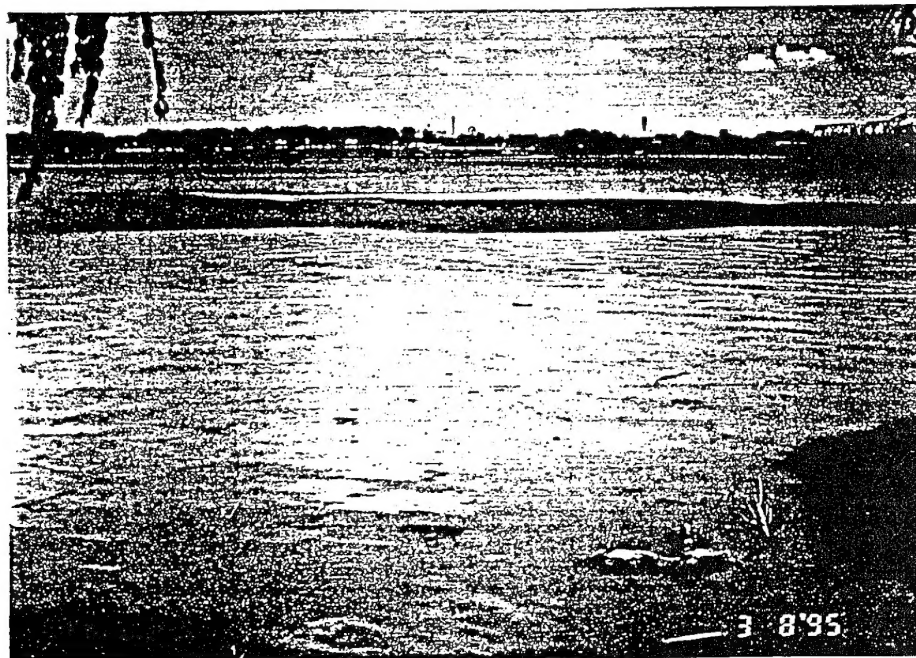
FIGURE A - MUD FLATS UPSTREAM OF MCALPINE L&D  
(looking toward Indiana shore)

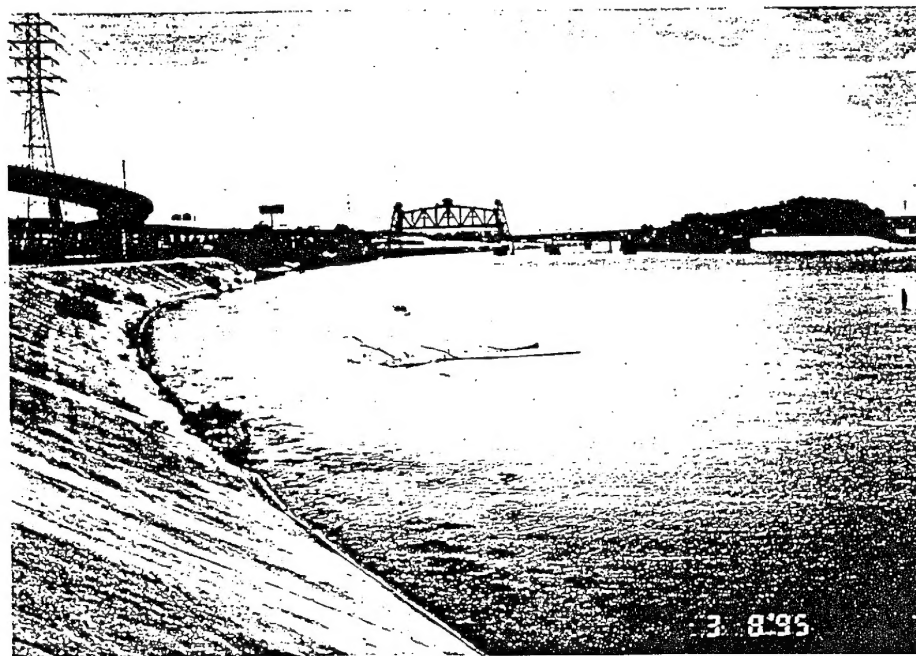
FIGURE B - MUD FLAT UPSTREAM OF MCALPINE WITH DEBRIS ACCUMULATION  
(looking downstream toward canal)

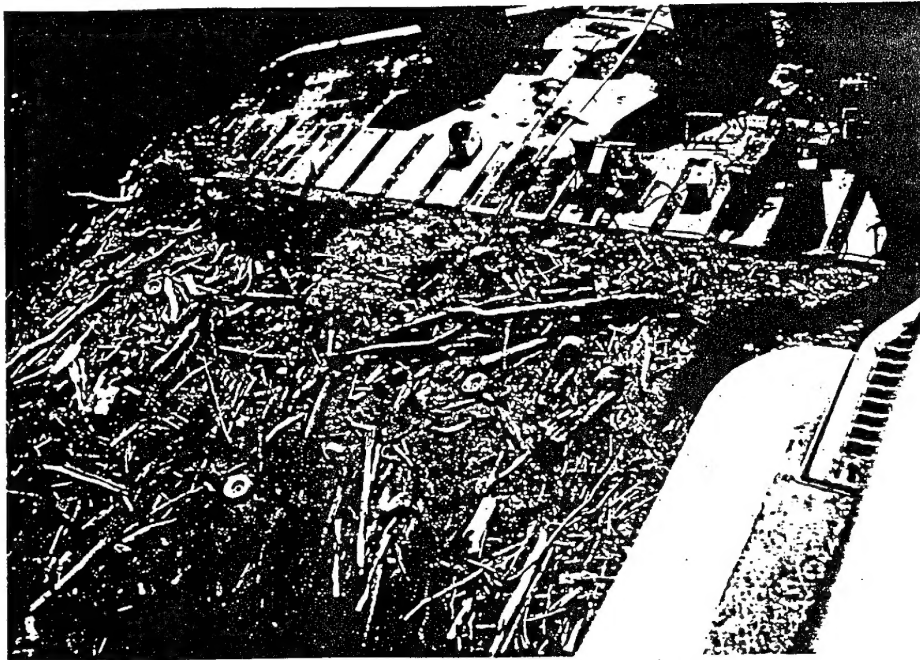
FIGURE C - DEBRIS ACCUMULATION - MARKLAND 600-FT LOCK CHAMBER  
(looking down into the lock)

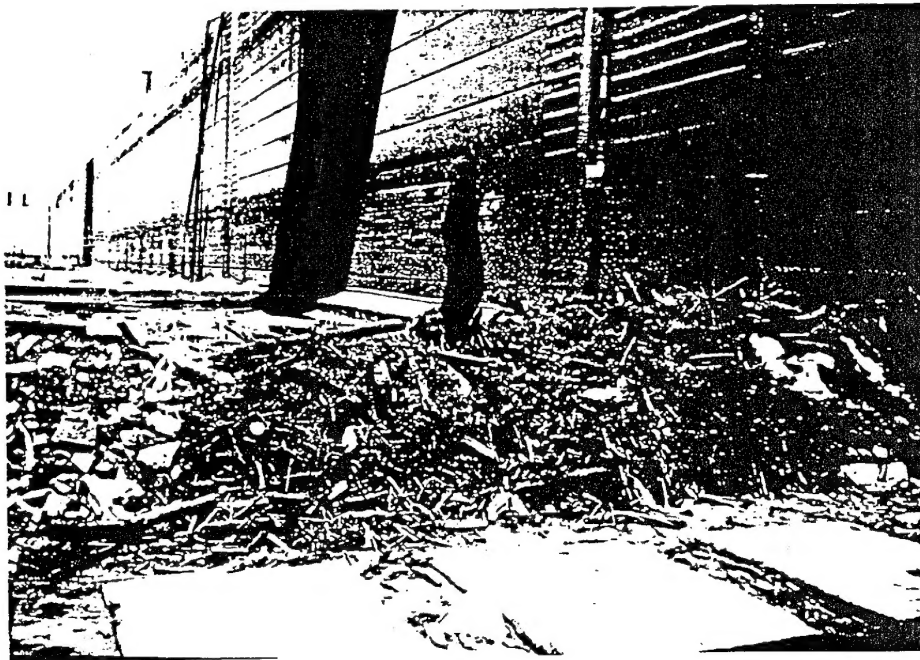
FIGURE D - DEBRIS ACCUMULATION - MARKLAND 600-FT LOCK CHAMBER  
(view from down in the lock chamber)
